NOAA's Restoration Efforts in Southern New England Coastal Mapping and Data Needs and Uses

Jim Turek, NOAA Restoration Center, Narragansett, RI

August 25, 2010

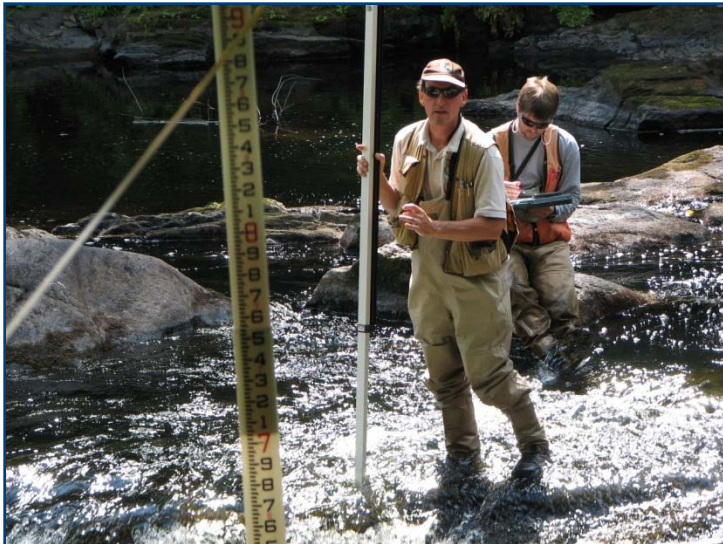
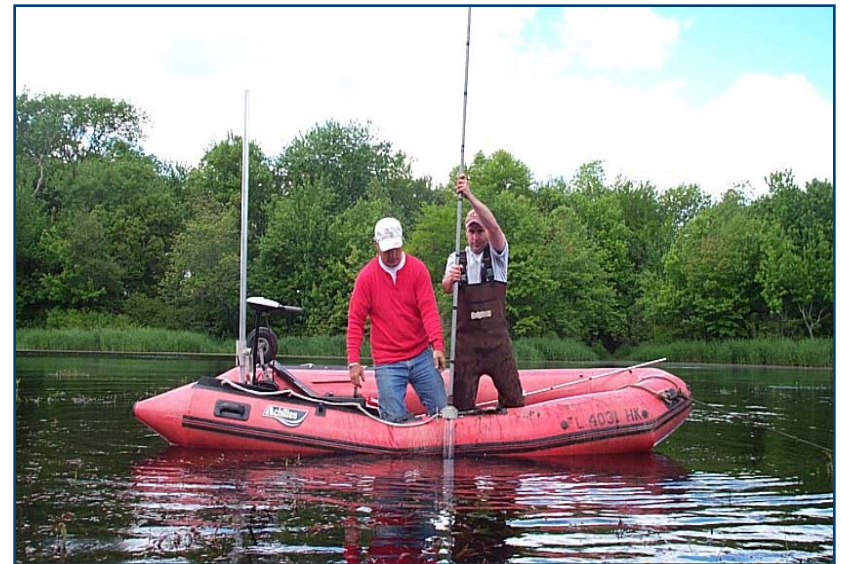
Dam Removals: Sediment Characterization and Transport Analysis

- Grain size, bulk density, water content, contaminant analysis
- HEC-RAS and Tractive Force analysis

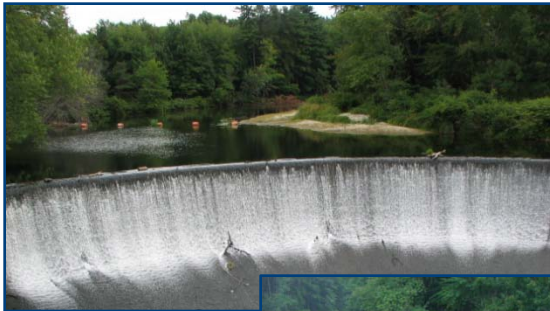
Merrimac Village Dam Removal, Souhegan River, NH

- 17-ft high dam
- Removal August 2008
- Tributary to Merrimac River

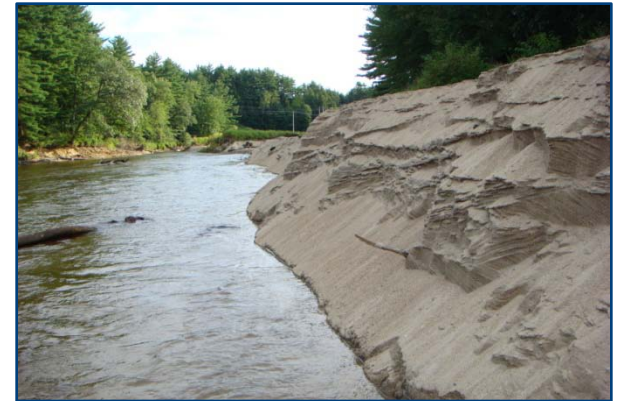
Upstream Headcutting

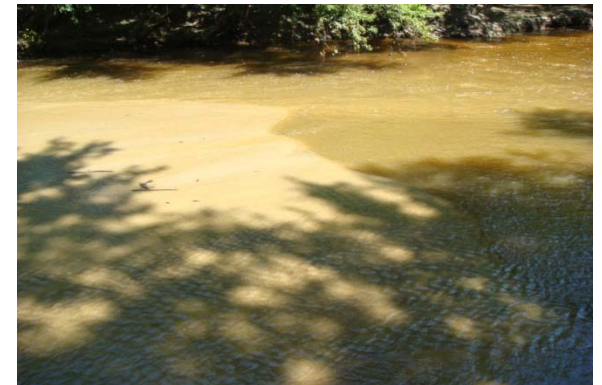
Downstream Deposition

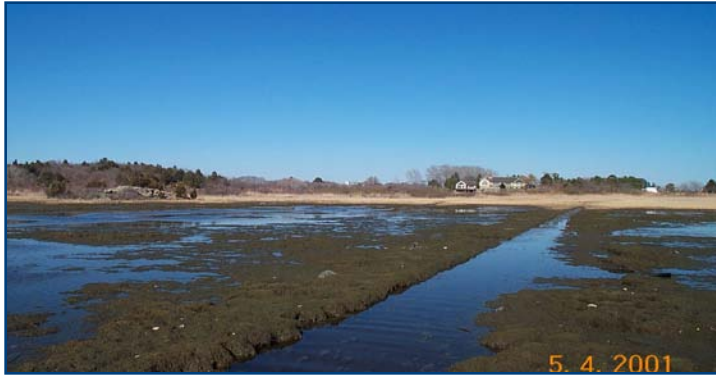
Gooseneck Cove Marsh,
Newport, RI

- Loss of normal diurnal wetting and drying; waterlogged peat
- Plant stress and mortality due to high sulfides
- Degradation of fibrous peat
- Erosion, suspension and transport
- Loss in elevation

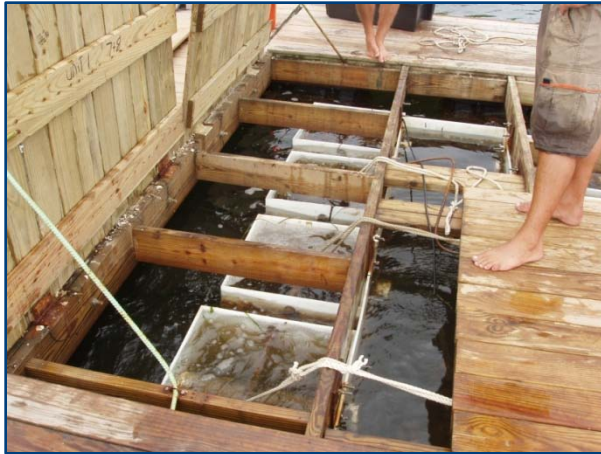
RIDEM Coastal Fisheries
Lab Upweller

Grow-out of 1+ mm seed to 15-20 mm seed for release

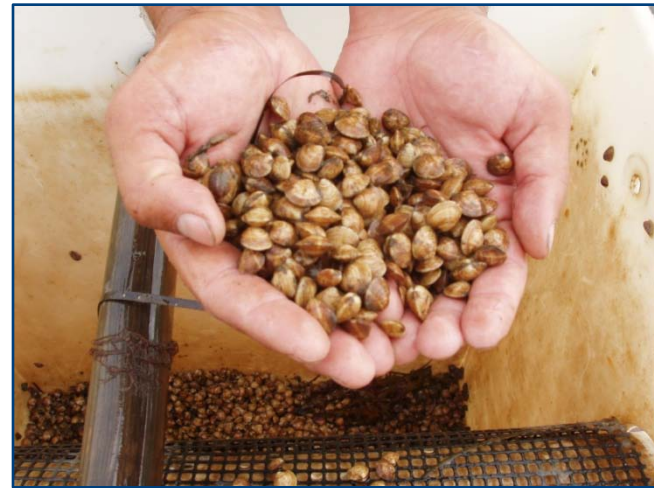
Quahog “Notatta” Seed

Released 761,000 quahogs – In 2005, compared pond bottom grow-out of 2nd year quahogs to seed grown in upweller. Results revealed that upweller produced much higher survival and slightly better growth, but demanded substantially higher investment of staff time.
